# Evaluation Of The Fused Slurry Silicide Coating Considering Component Design And Reuse

MCDONNELL DOUGLAS ASTRONAUTICS COMPANY • EAST

TECHNICAL REPORT AFML-TR-70-154

December 1970

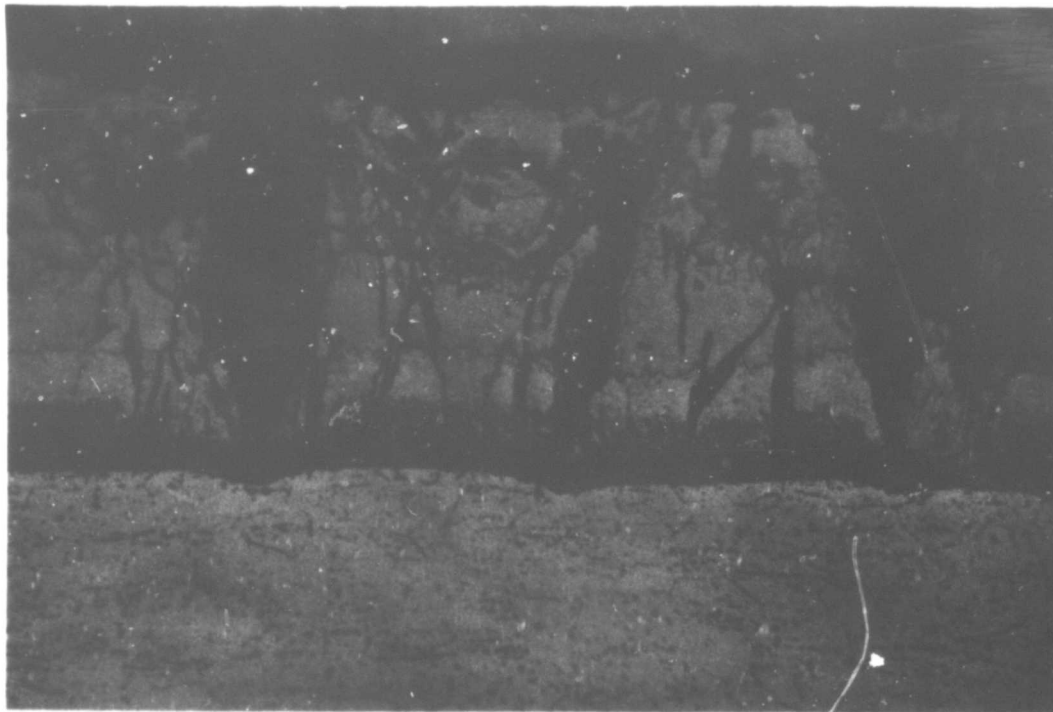
Figure 47 R-512E Coated Cb-752 After 35 Simulated Reentry Cycles 500X  
Under External Pressure/Low Stress Conditions

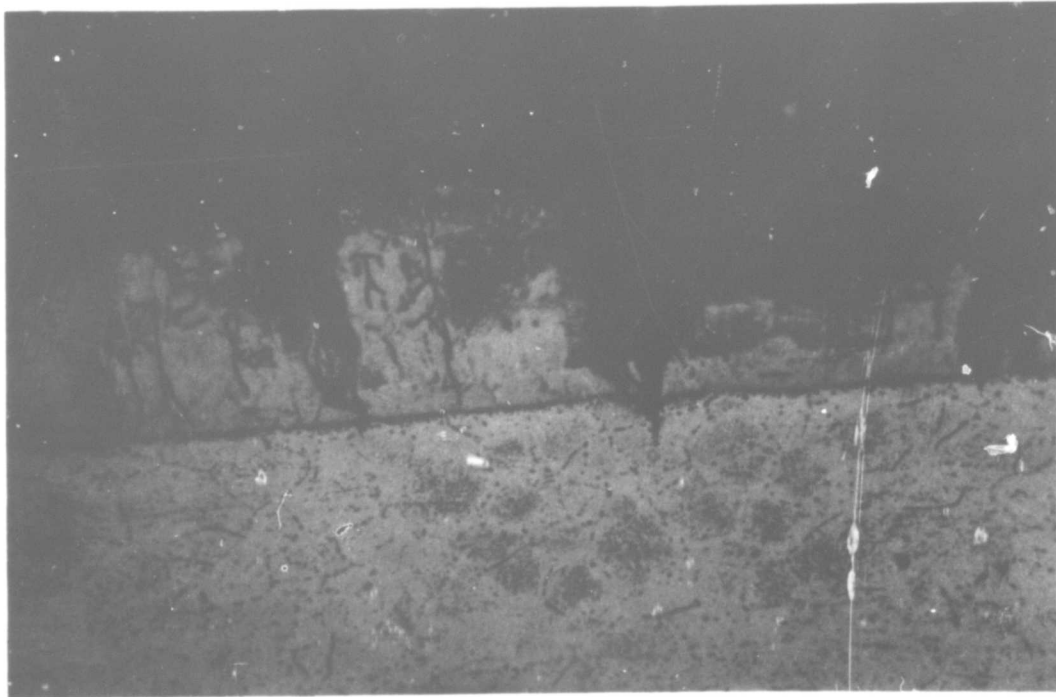
Figure 51 R-512E Coated Cb-752 After 24 Simulated Reentry Cycles 500X  
Under Internal Pressure/Low Stress Conditions

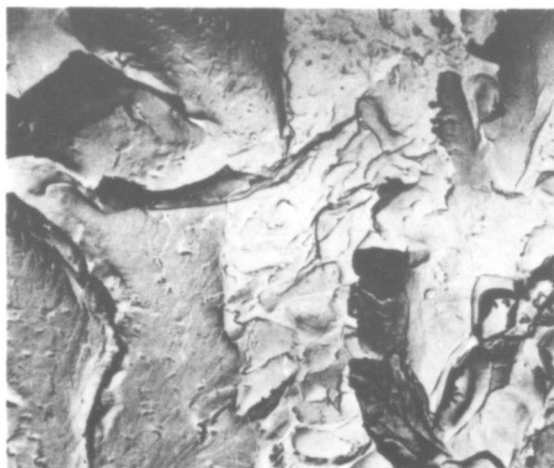
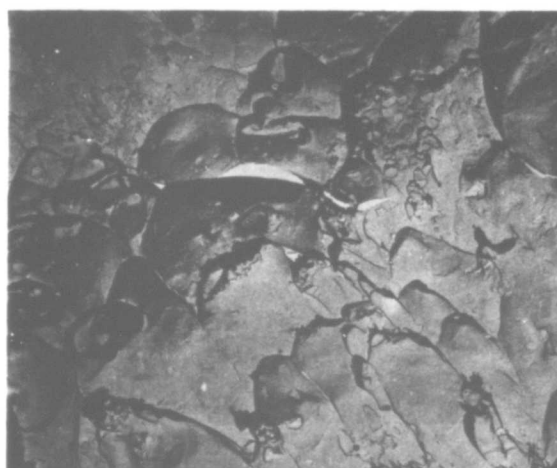
Figure 57 Replicated Fracture Surface Areas Of Specimen 1

The microscopic features of the fracture surfaces as observed in the light microscope indicate fracture origin at both edges of Specimen 1 and at one edge of Specimen 2. The remaining areas of both specimens consisted of shear fracture. Electron fractographic examination of Specimen 1 revealed a duplex structure at the origin, Figure 57 Area A. The duplex structure consisted of a mixture of brittle cleavage rupture and ductile dimple rupture. The shear region exhibited elongated dimples typical of a ductile shear rupture, Area B of Figure 57. Both the origin and shear region on Specimen 2 revealed ductile features typical of an overload failure, Figure 58.
